BEAM & FOLDING SYSTEM - CARE AND MAINTENANCE

FARRIER MARINE, INC.

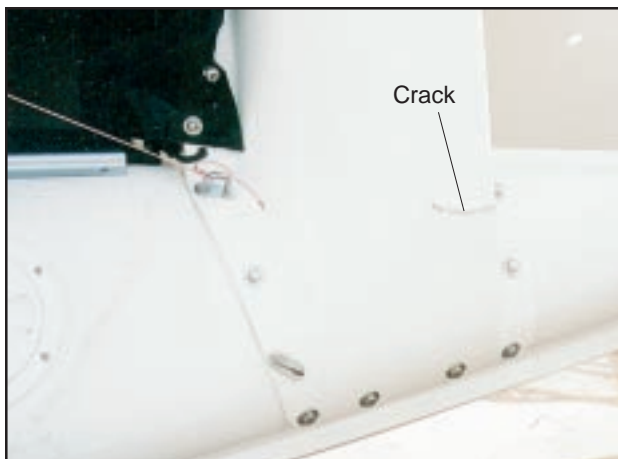
The beam tops of this F-27 hit a low overhead bridge while being trailered. The crack visible in the top continues around the aft side. Such a crack should not be repaired as the carbon fiber inside is probably considerably weakened. The beam needs to be replaced otherwise it may suddenly fail

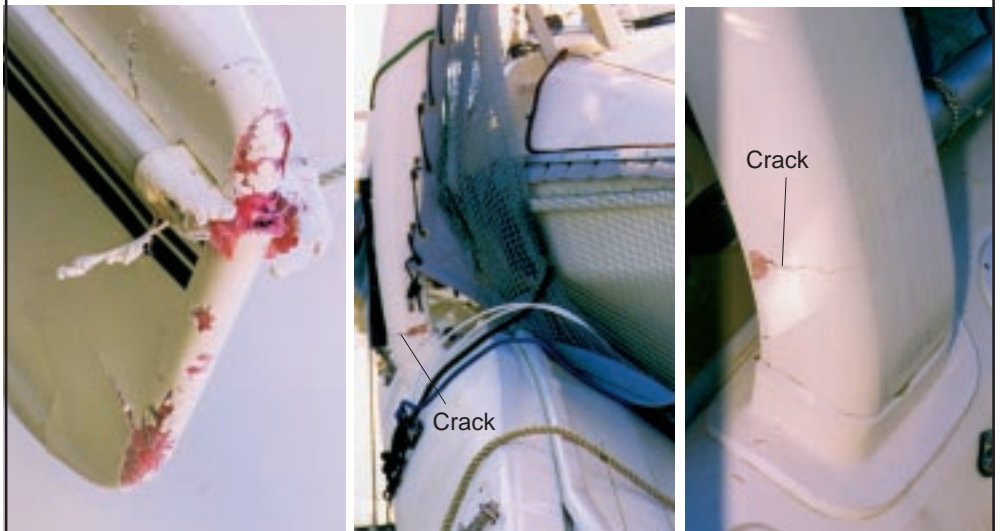
If there is this much bow damage (F-31 float Bow)

...then fwd. beam may also be damaged (see crack on fwd. side)

...plus even the aft beam (aft side in this case)

Collision damage can be serious and beams should always be checked carefully and then monitored after any significant collision. Photos shown damage to an F-31 after a major float bow collision. Both beams were replaced as a precaution.

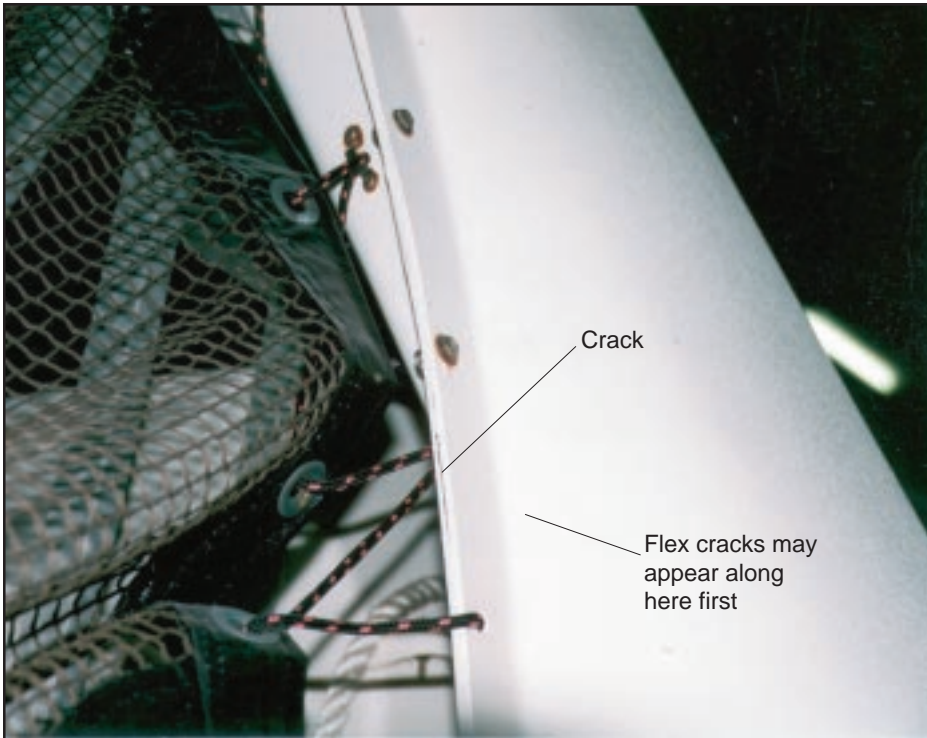
This F-27 forward beam has the most commonly seen join flange crack. While not initially serious, such cracks can quickly become serious if not repaired promptly. They should not be allowed to get any worse than this.

The most common problem area has been on the horizontal forward flange join on the F-27 forward beams, at the outer end just inside the float. Beam break tests have shown that this area is actually put under a higher stress with more of a peeling load, rather than the usual shear loads, due to the curved beam shape in this area. Such a concentrated and more difficult load is more likely to find any weak areas.

Any failure seems to start at the inside aft edge of the flange, where the stress is highest, and some external flex cracks may first become visible, as per the drawing. The actual glue line crack then slowly makes its way forward to eventually become visible as a crack on the outside.

Should a crack be found, the repair is relatively easy **if done early**. The crack should be cleaned out by inserting a hacksaw blade or thin knife blade and moving it in and out to remove any loose debris, and roughen both surfaces. If using a knife, warp a strip of emery cloth or sandpaper over the knife. If a long crack, it can be levered apart a little for better access.

Then wedge apart with something like matchsticks and reglue using Lord Chemical's Fusor epoxy 320/322 glue

Once cured, the flange should then have additional bolts added as detailed, and again note that these are best located as far aft as possible.

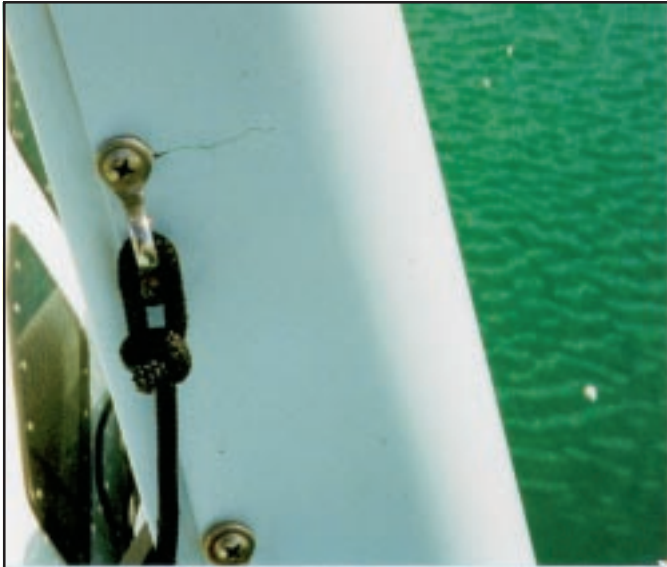
The vertical join line as used on both sides of the F-25A, F-31 or aft side of the F-27 and F-28 beams, are also areas to watch. Should the glue line fail here, and be undetected, the failure will grow along the join flange until it reaches a bolt, which then acts as a stress raiser. A vertical crack running up the side of the beam may then develop from that bolt. Now it gets serious and must be repaired without delay.

This beam shows a vertical crack that may eventually develop from a vertical flange glue line failure if not seen and repaired early enough - now it becomes more serious

Vertical cracks that have developed from a bolt on the side of a beam are still easily repairable, but procedure is a bit more complex as an additional backing plate has to be fitted inside the beam. Full details are available on request.

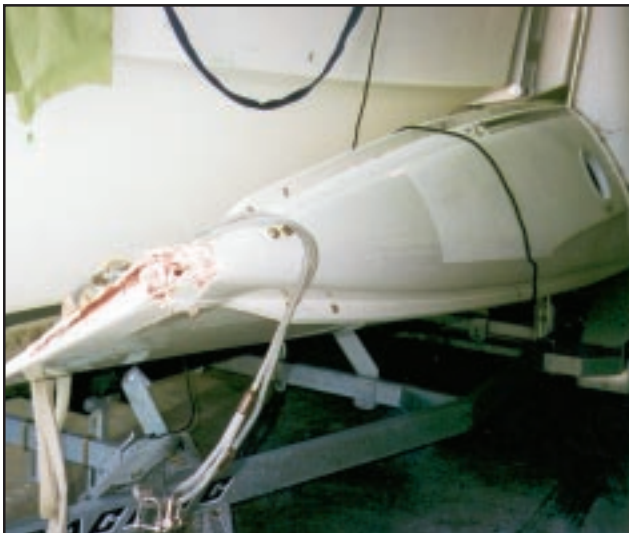
Extensive damage to bow can be seen, plus cracks in fwd. beam

This F-27 hit a large steel marker buoy at high speed, but still survived. However, note extensive damage to bow, float hull and outer ends of beams. The joint flange on the aft side of forward beam was also extensively delaminated and these beams had to be replaced. If such cracks were just gelcoat repaired then there would be a danger of sudden unexpected failure later.

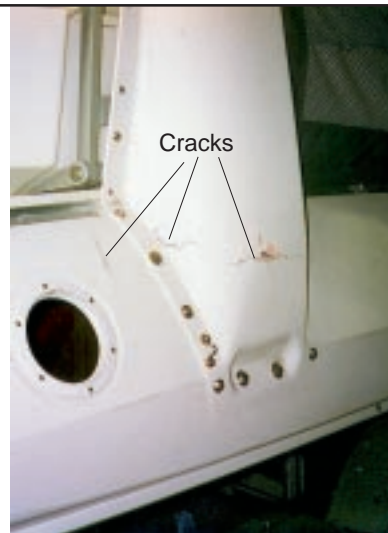
Close-up of forward beam - this is too damaged to risk repair

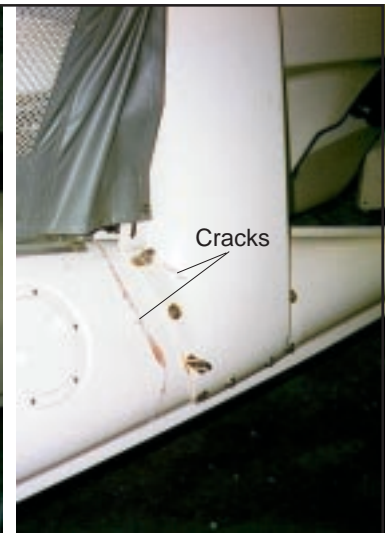
Aft beam damage - note also large crack running around float deck

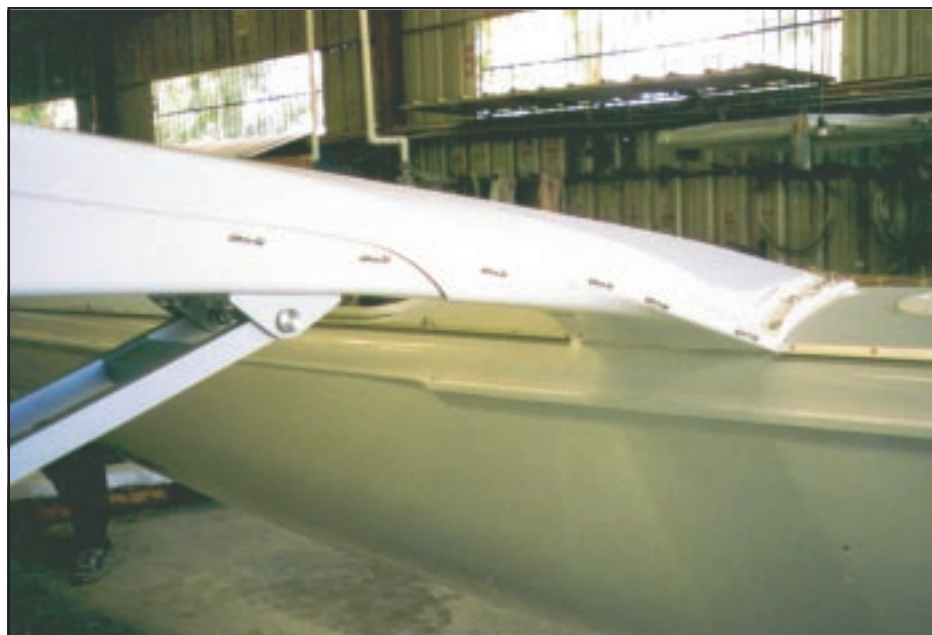
The latest F-28 Fwd. Beam cover which eliminates the forward join flange.

To help eliminate any reliance on glue bonds, the forward beam glue flange has now been removed on current F-28s. The join is now covered by an external cover, similar to that used on the aft beams, but with a more streamlined and appealing shape, and extending down to the float.

This can be retrofitted to earlier F-27s if wished, to also eliminate the join flange. It is just a matter of cutting the existing join flange off, filling and grinding the join seam smooth, taping over with glass tape, and then gluing on the new cover/fairing. However, the aft vertical join flanges will still need to be regularly checked.
