BEAM & FOLDING SYSTEM - CARE AND MAINTENANCE

FARRIER MARINE, INC.

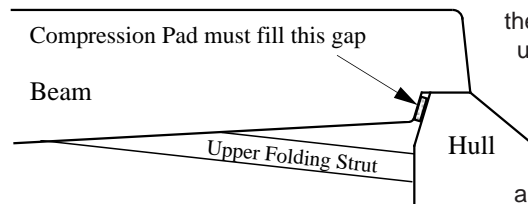
Compression Pads: All F-24, F-25, F-82, F-9A and F-31 owners should regularly check that the plastic compression pads on the inner ends of the beams are properly in position and fill the near vertical gap that may exist between the end of the beam and the pads on the hull. If any inwards movement is allowed here, the full compression

load on the beams is directed through the Upper Folding Strut mounting points which are not designed to take this load for long.

The Upper folding strut mounting points can then be damaged. However, although this does not threaten the boat's structural

safety, as the beam simply moves in slightly to bear directly on the hull, repairs can be expensive. Note that this gap will vary from boat to boat, and sometimes a compression pad may not be required.
